Technical Inspection Report  
Bureau of Ordnance Group

OPERATION CROSSROADS.

TESTS 'A' AND 'B'.  
VOLUME III.  
PART I.  
Photographic  
Appendix [u]. 8

Subject: Bureau of Ordnance Material Group Final Report for Tests "A" & "B".

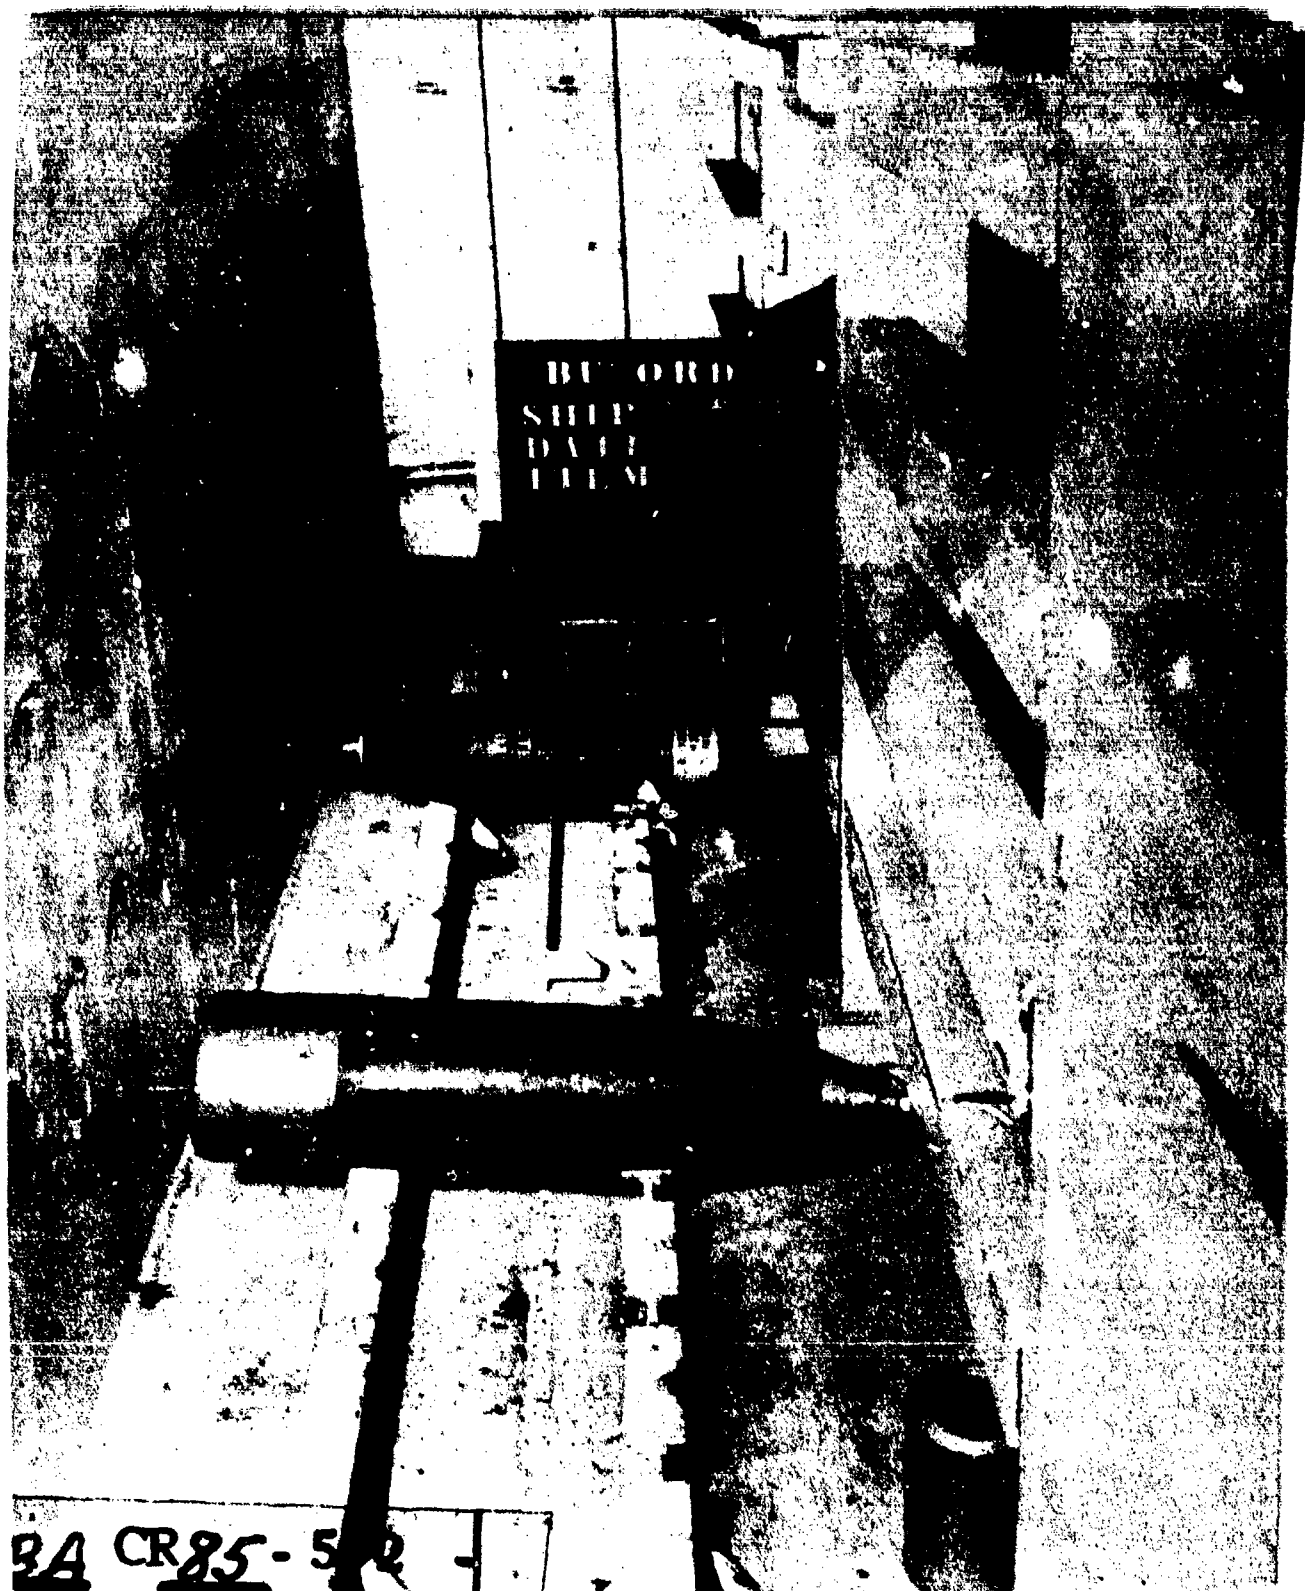
U.S.S. CATRON (APA-71) - Before Able  
Shows the 5" O Aircraft Rocket Heads, plaster loaded  
and fuze, in position prior to Test "A".  
Photo. No. BA-CK-85-592-1.

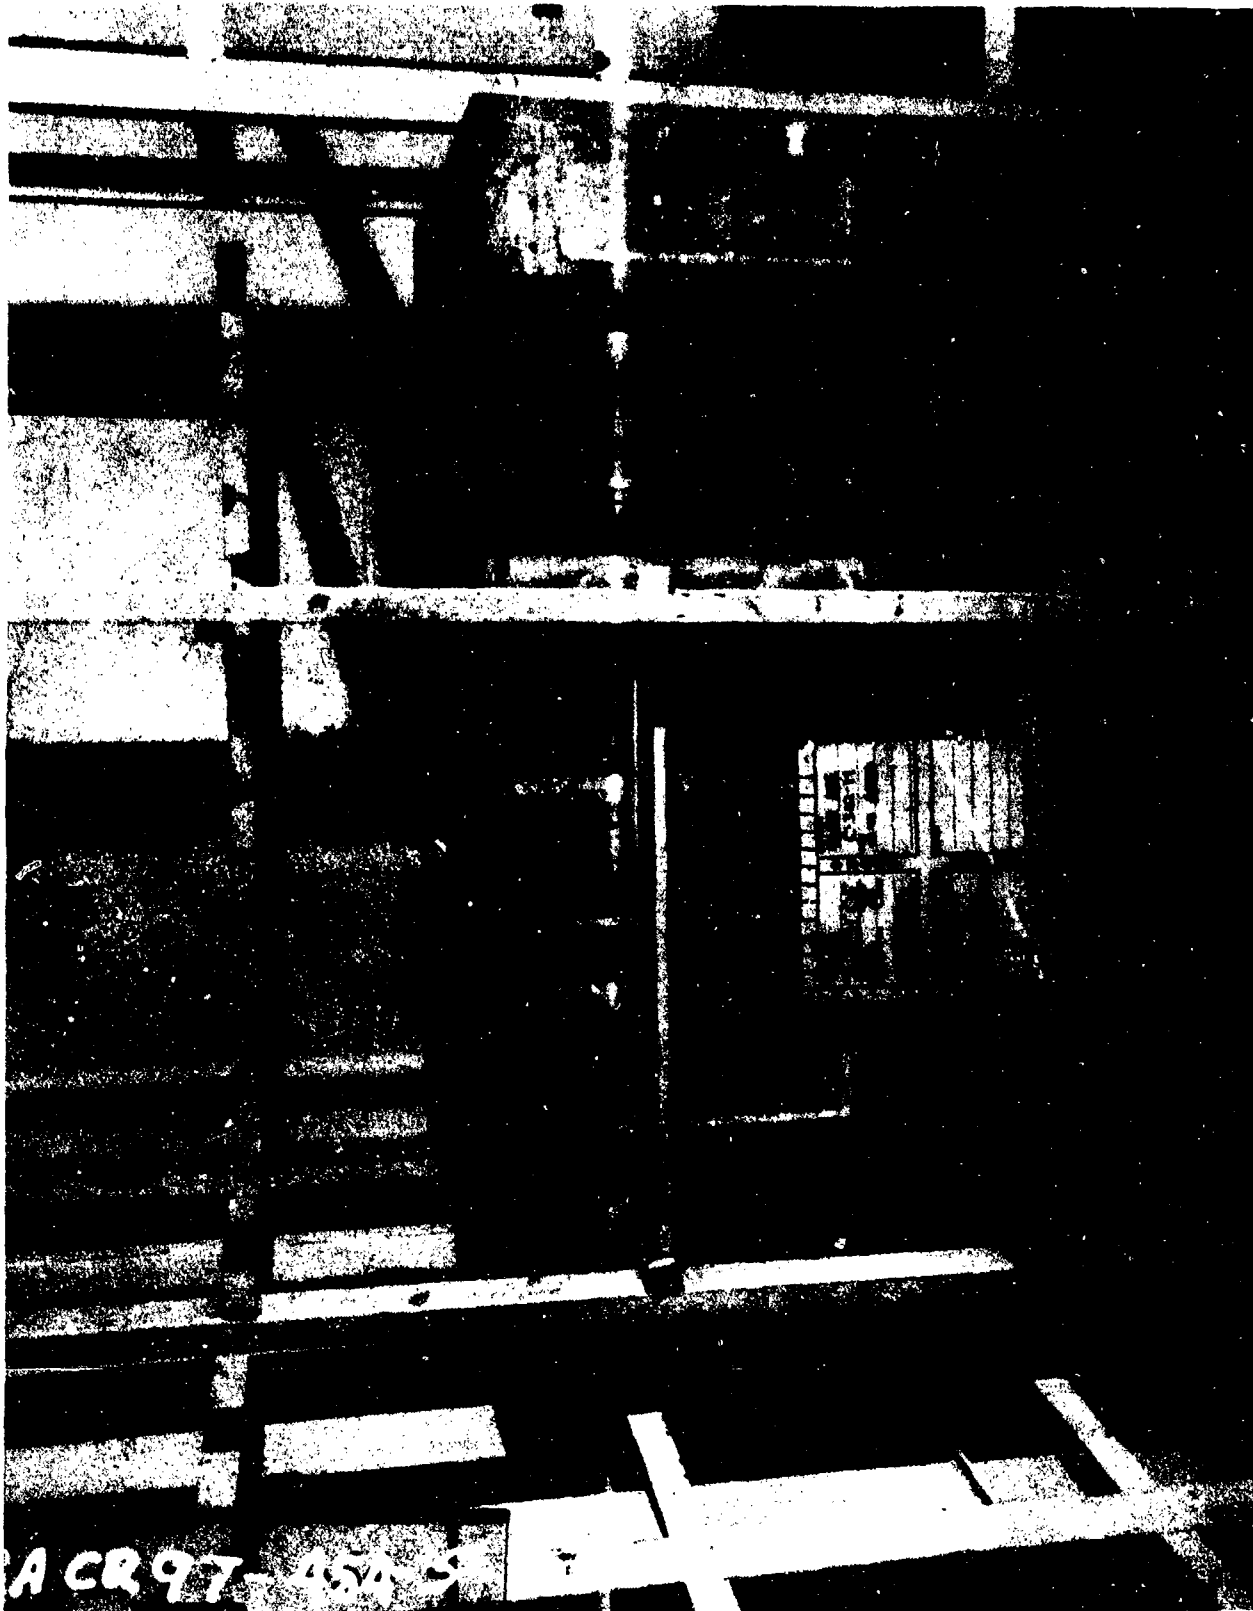
U.S.S. BRISCOE (APA-65) - Before Able  
Shows the 40 MM Magazine, C-302-M prior to Test "A".  
Photo. No. BA-CR-97-454-5.

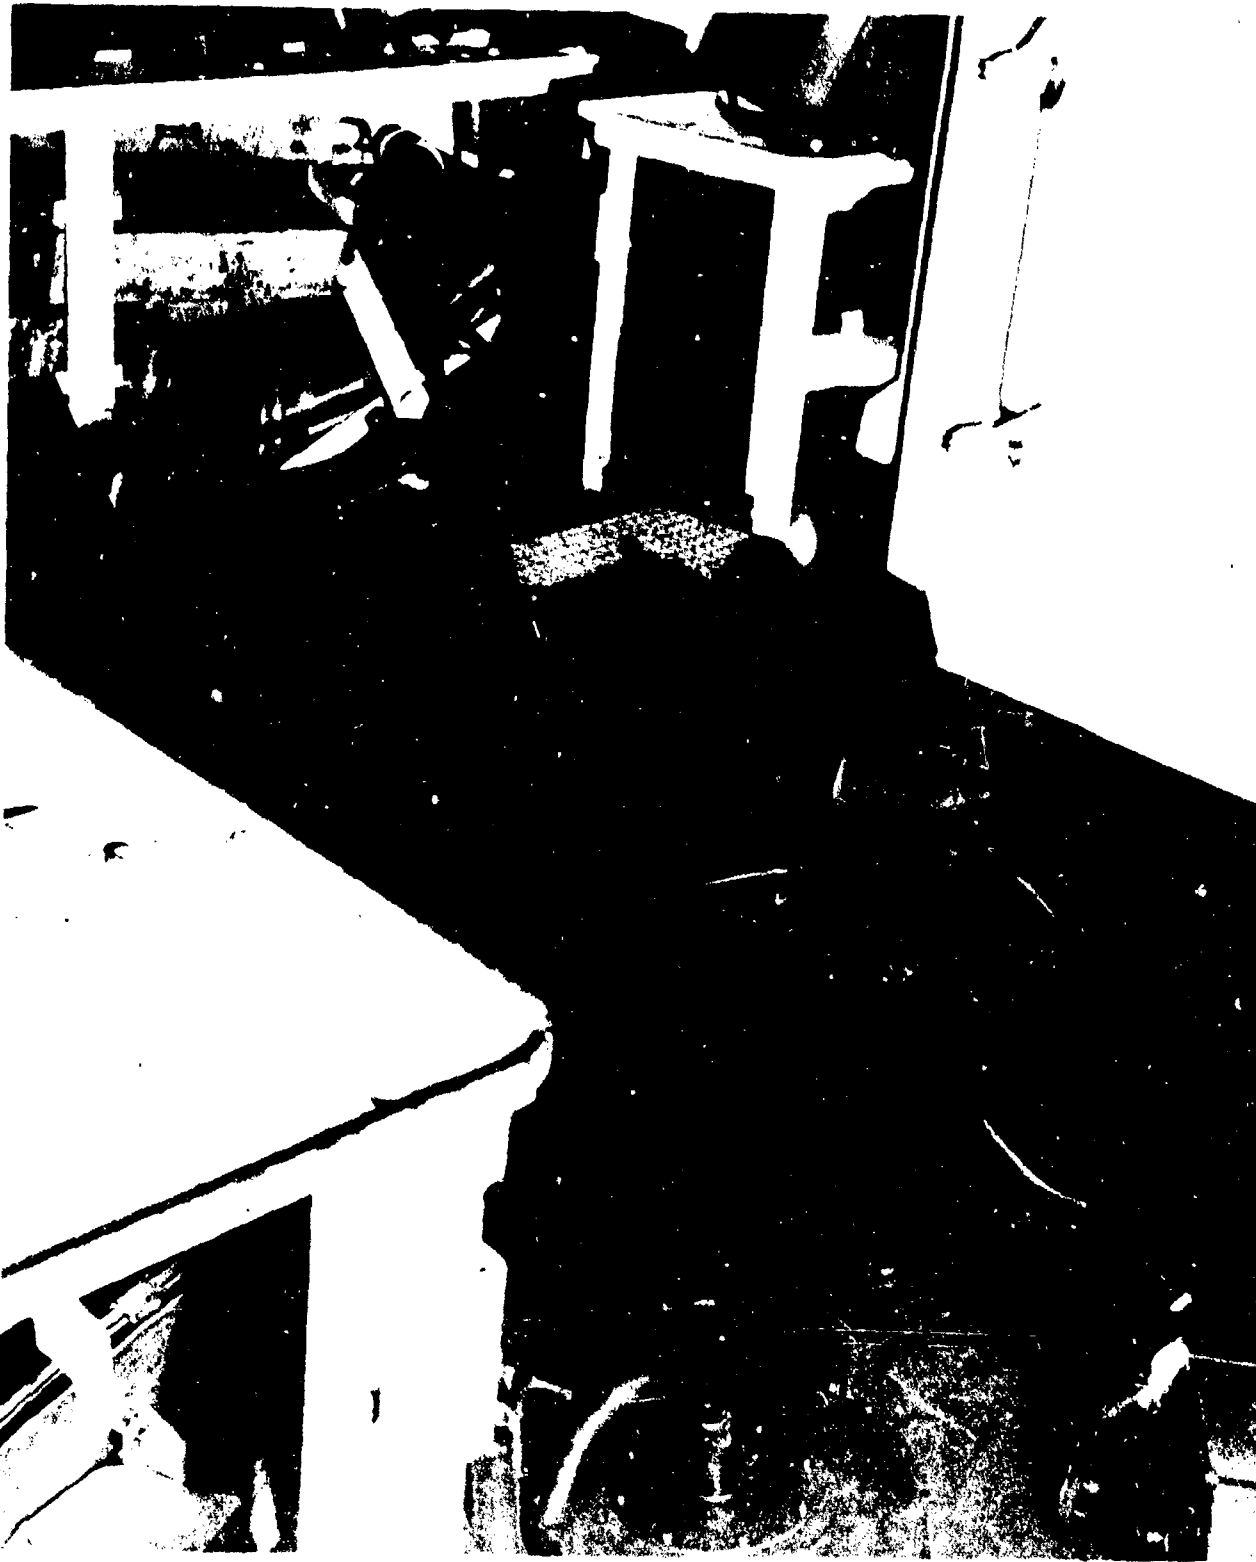
U.S.S. BRISCOE (APA-65) - After Baker  
 Shows the effect of shock to the 20 MM Magazine Ready Service Stowage in the 20 MM  
 Clipping Room, E-0109-M. A feasible securing device should be provided for the racks  
 holding the loaded Magazines to prevent them from becoming disengaged when subjected  
 to a violent upward movement.  
 Photo. No. AB-CR-97-4046-3.

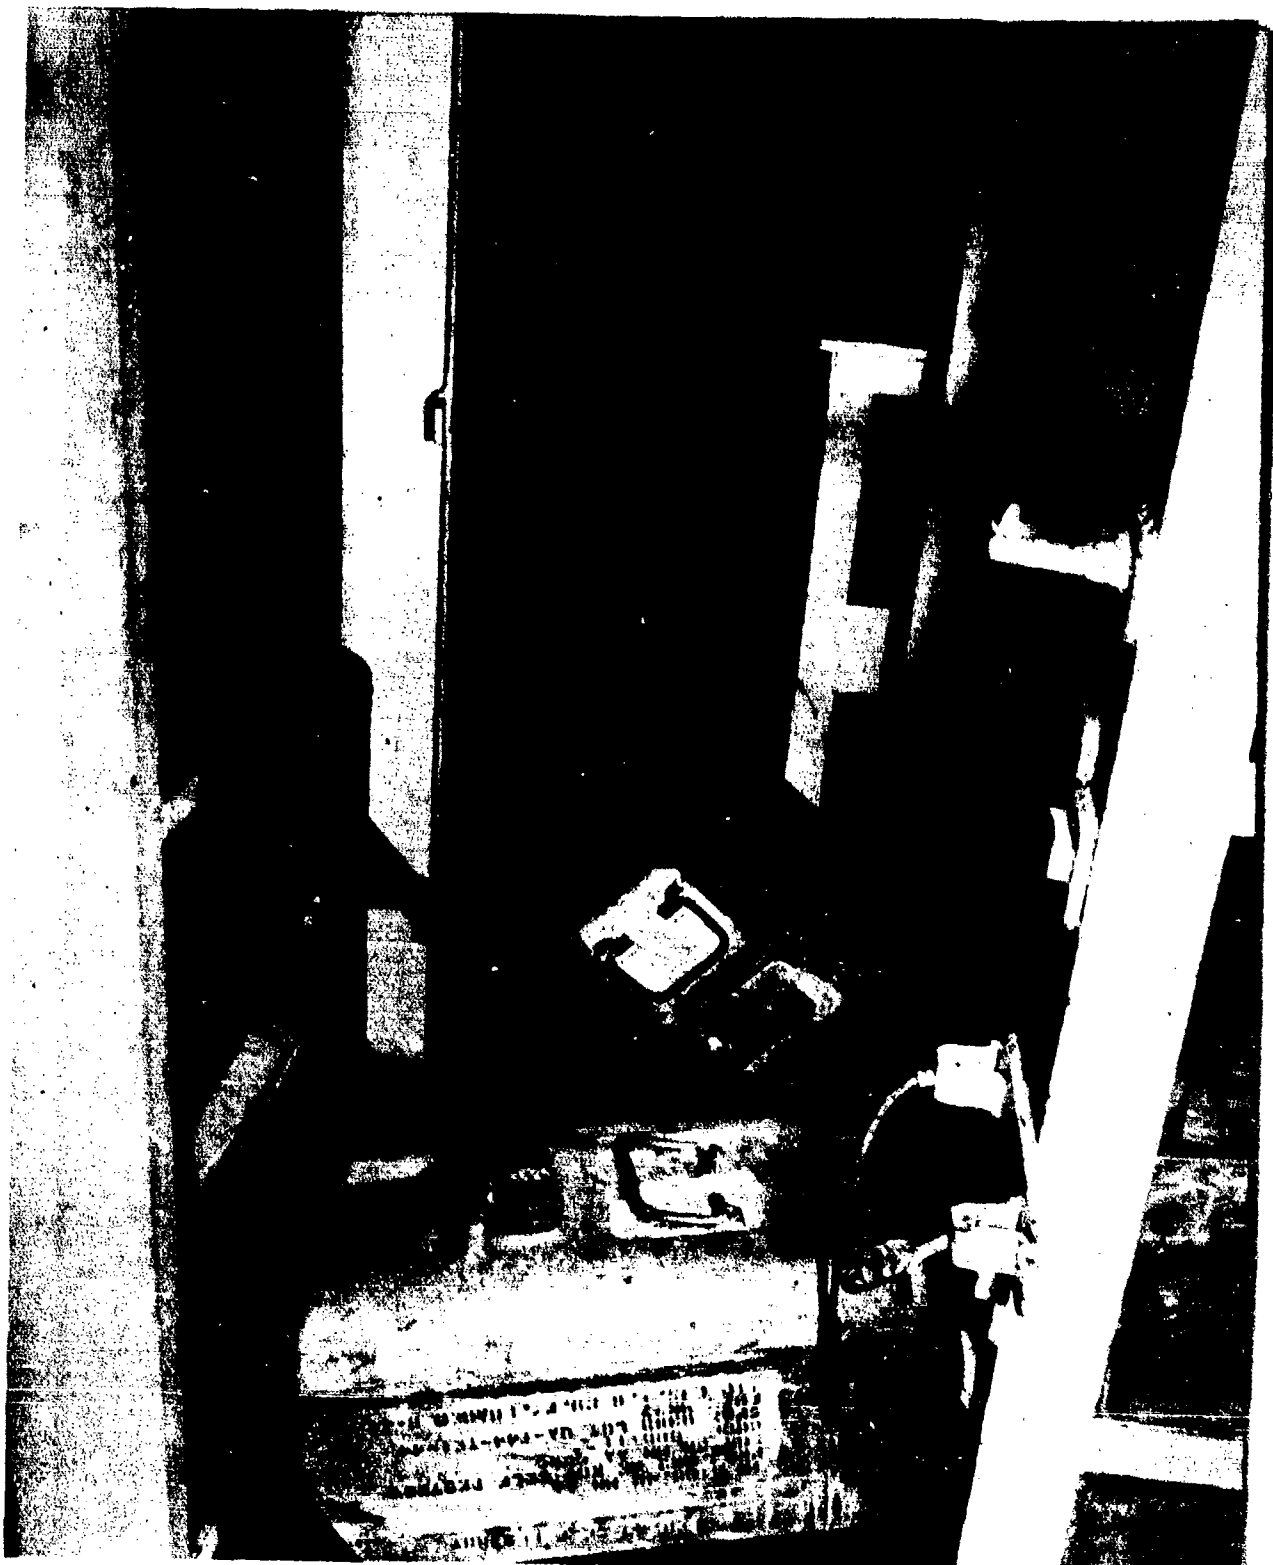
U.S.S. BRISCOE (APA-65) - After Baker  
Shows the effect of shock to the 40 MM Ammunition Stowage  
in the 40 MM Ready Service Room, C-0104-M. The failure  
of battens and stanchions was marked.  
Photo. No. AB-CR-97-4046-4.

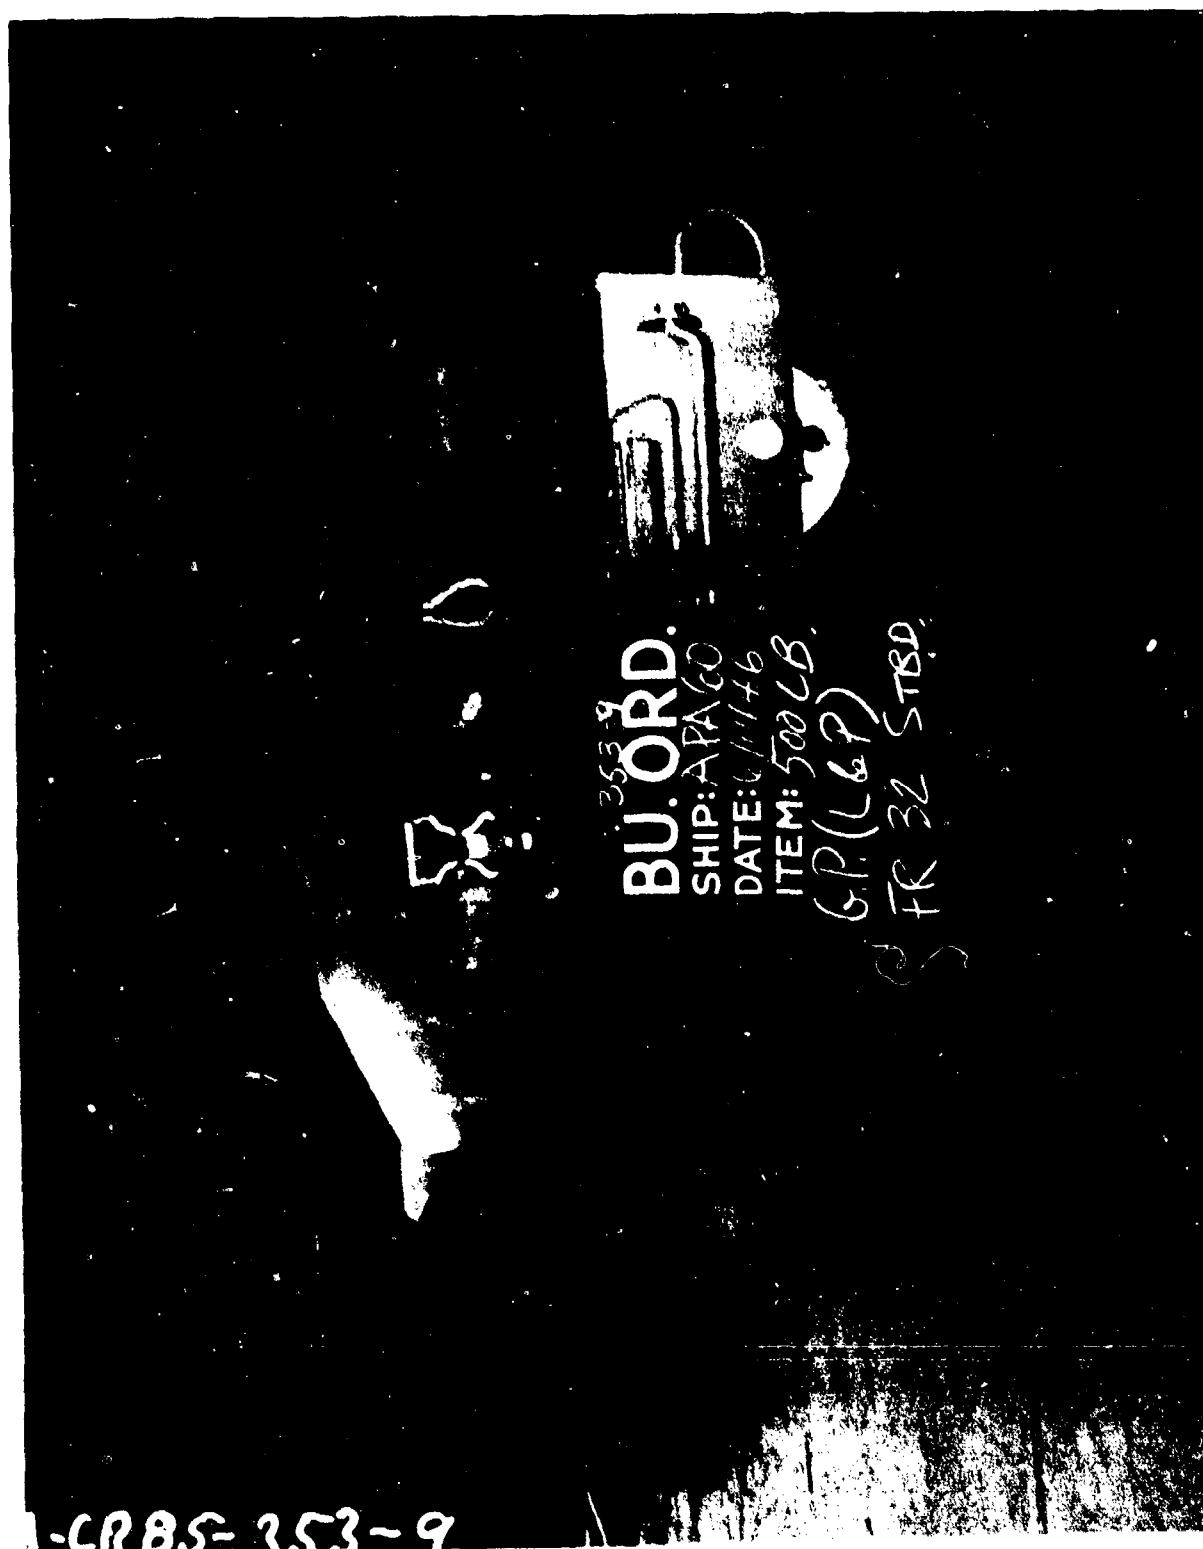
U.S.S. BANNER (APA-60) - Before Able  
Shows the 500 lb., general purpose,  
aircraft bomb, AN-M64A1, TNT loaded and with  
shipping plugs in place, in position prior  
to Test "A". The securing arrangement to  
the deck as seen in the photo was employed for  
all aircraft munitions exposed on weather decks.  
Photo. No. BA-CR-85-353-9.

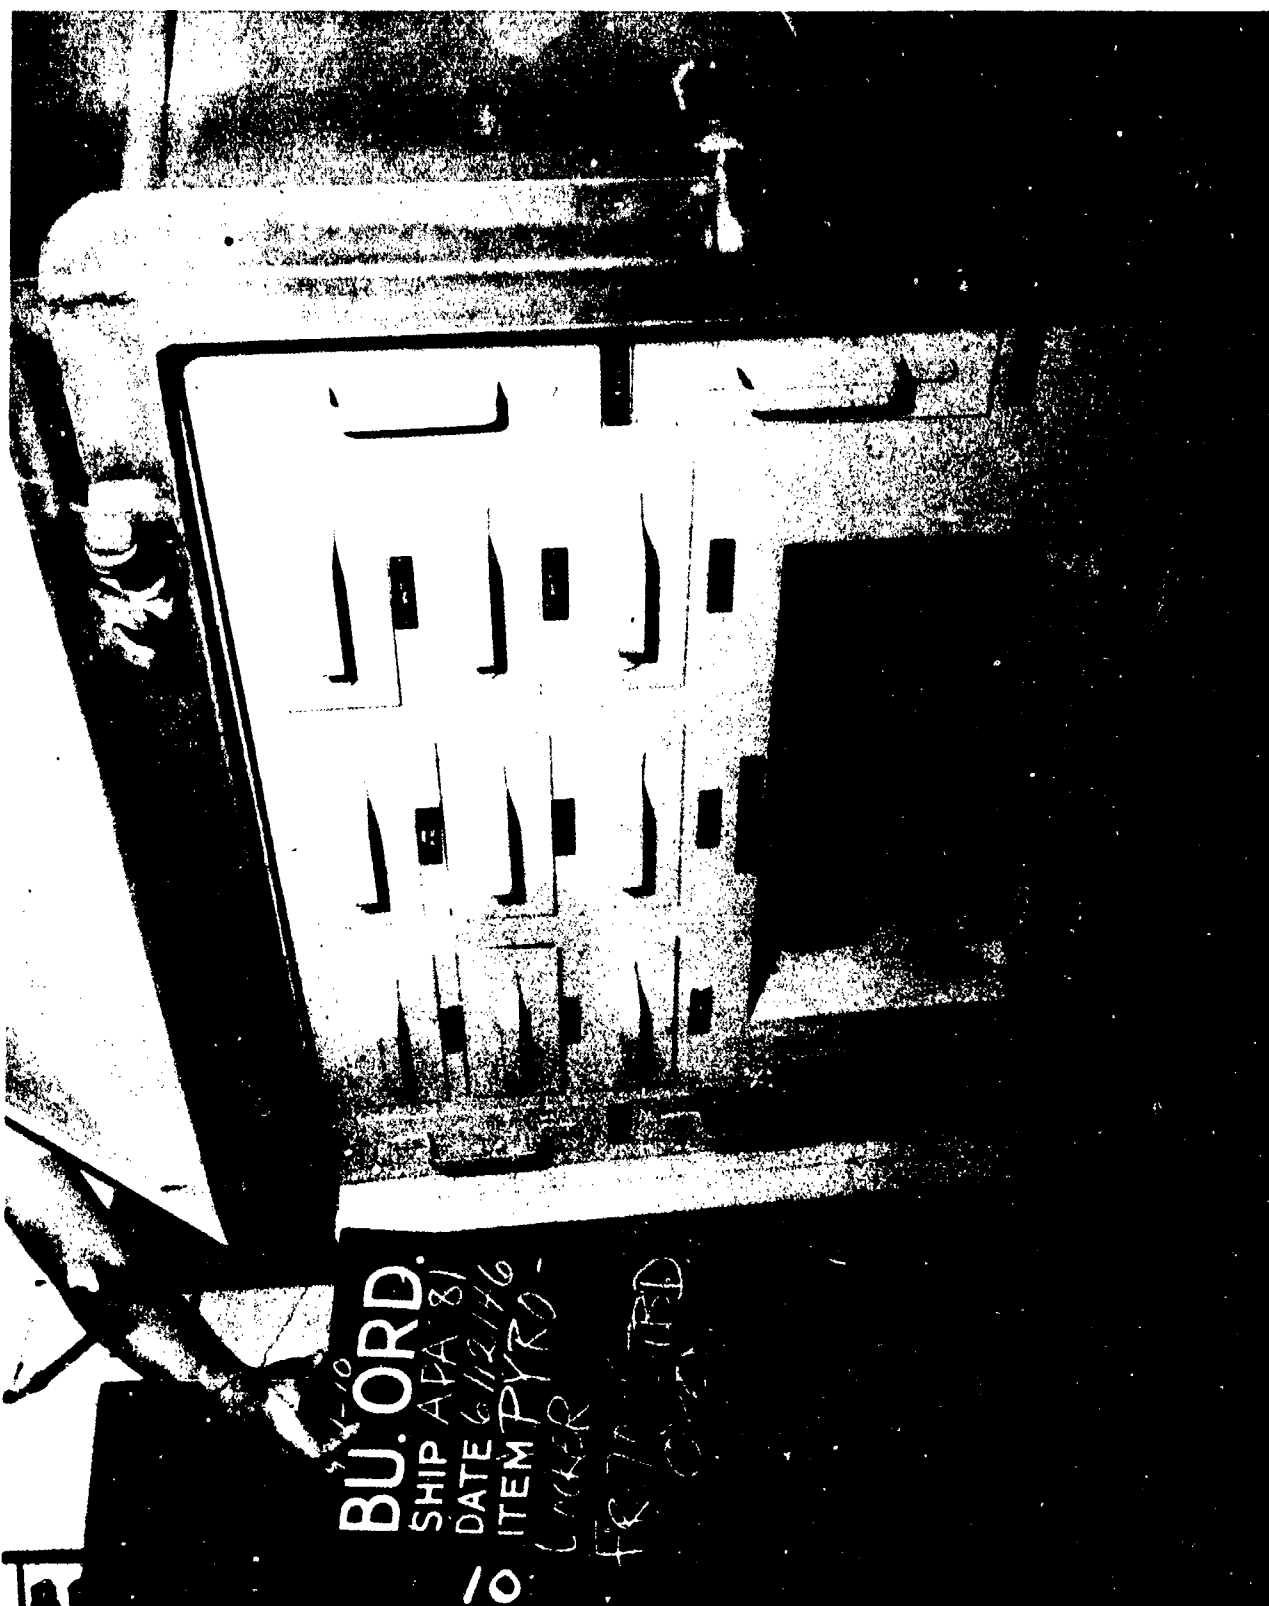
U.S.S. FALLON (APA-81) - Before Able  
Shows the Pyrotechnic Ammunition Stowage in the  
Pyrotechnic Locker prior to Test "A". Munitions as  
shown is Service Ammunition.  
Photo. No. BA-CR-60-917-10.

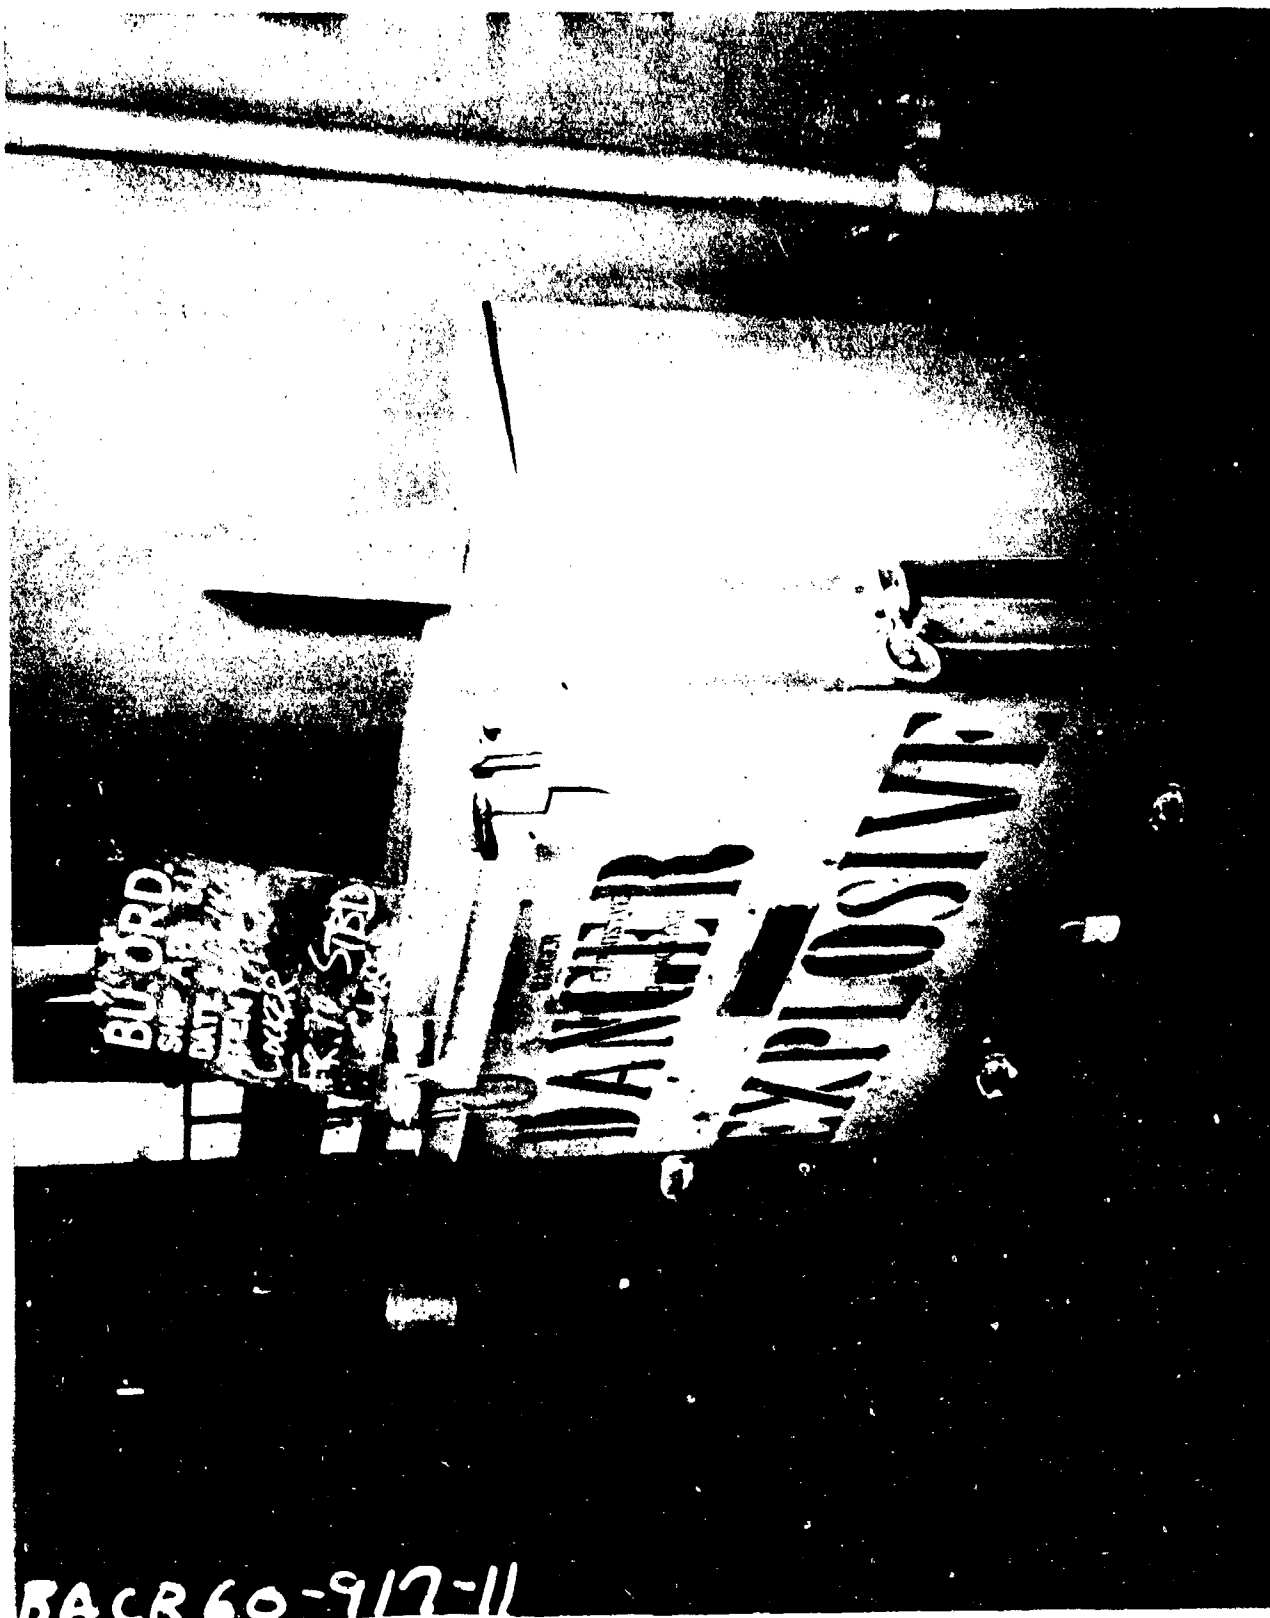
U.S.S. FALLON (APA-81) - Before Able  
Shows the condition of readiness of the Pyrotechnic  
Locker prior to Test "A". Service Pyrotechnic Munitions  
were employed in the Test.  
Photo. No. BA-CR-60-917-11.

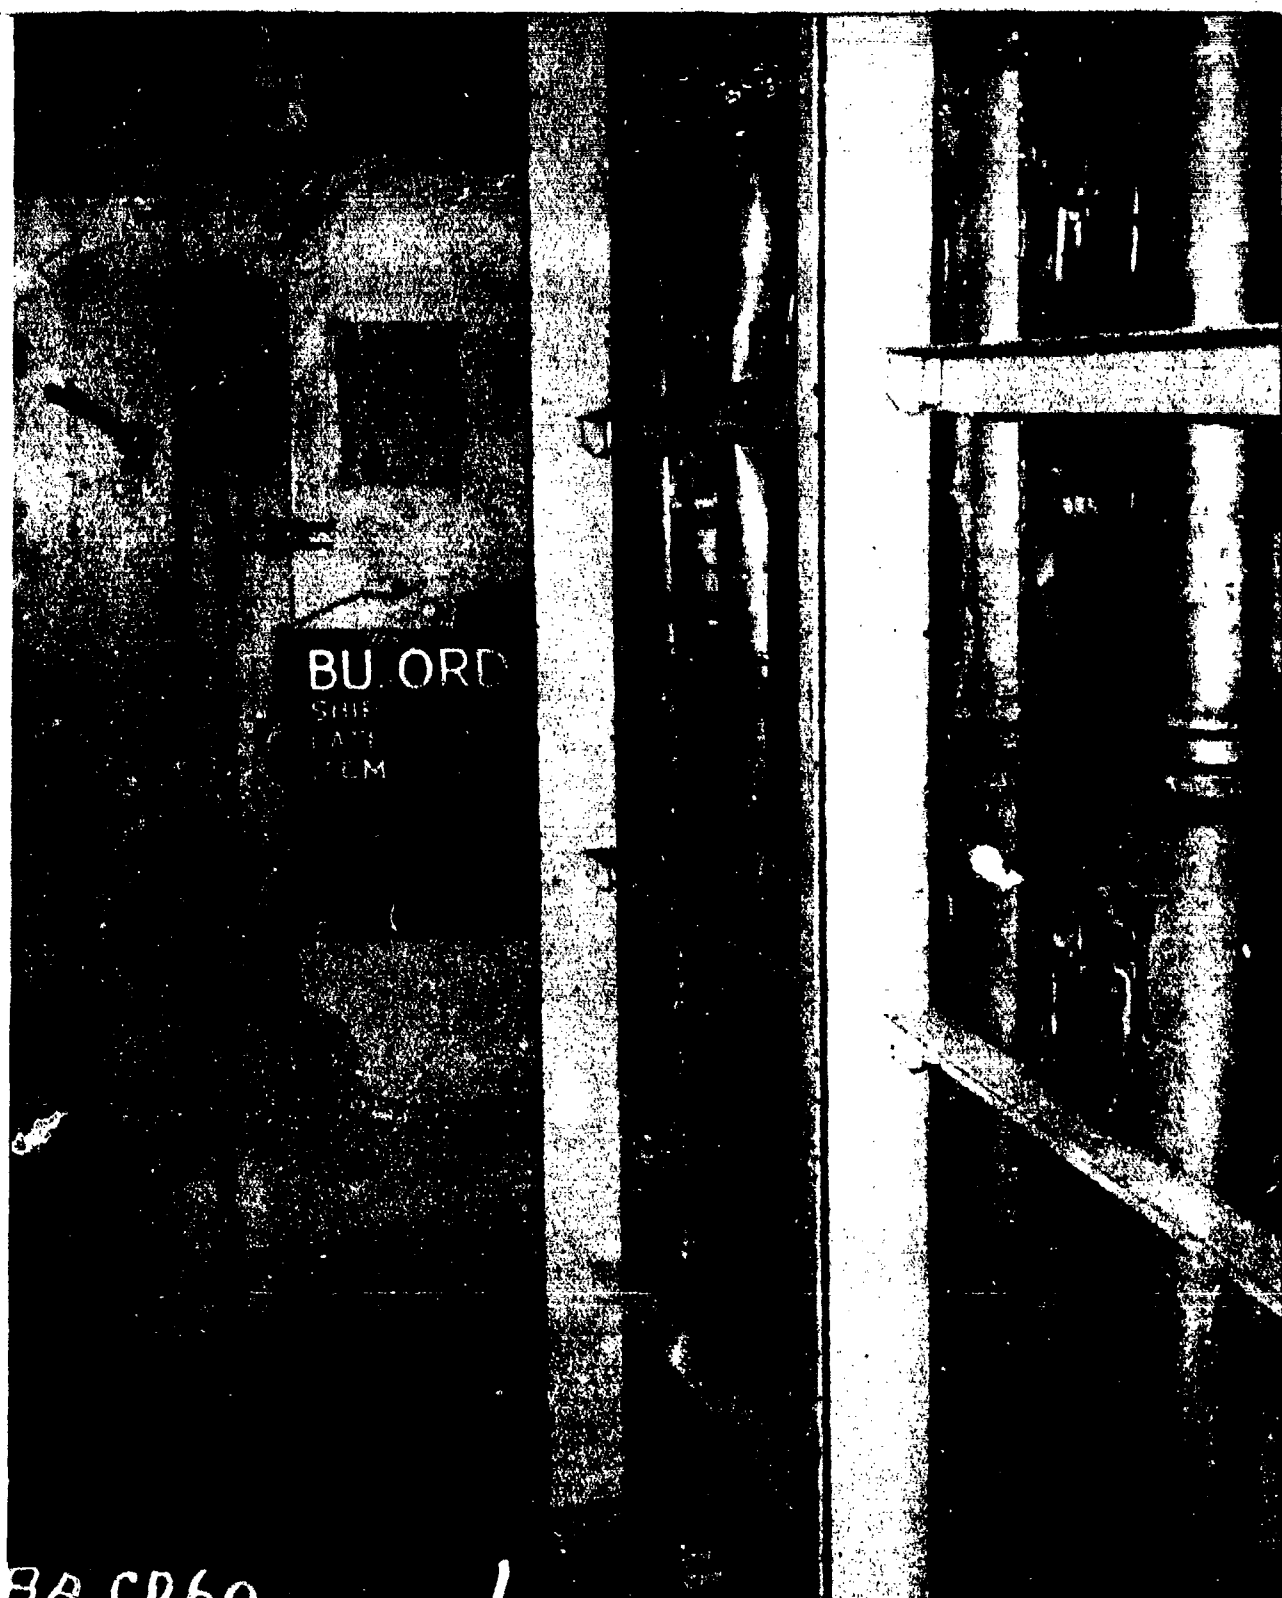
U.S.S. FALLON (APA-81) - Before Able  
Shows the 40 MM Ammunition Stowage in the Ready  
Service Room, C-0104-M prior to Test "A". All  
ammunition is Service Ammunition.  
Photo. No. BA-60-918-1.

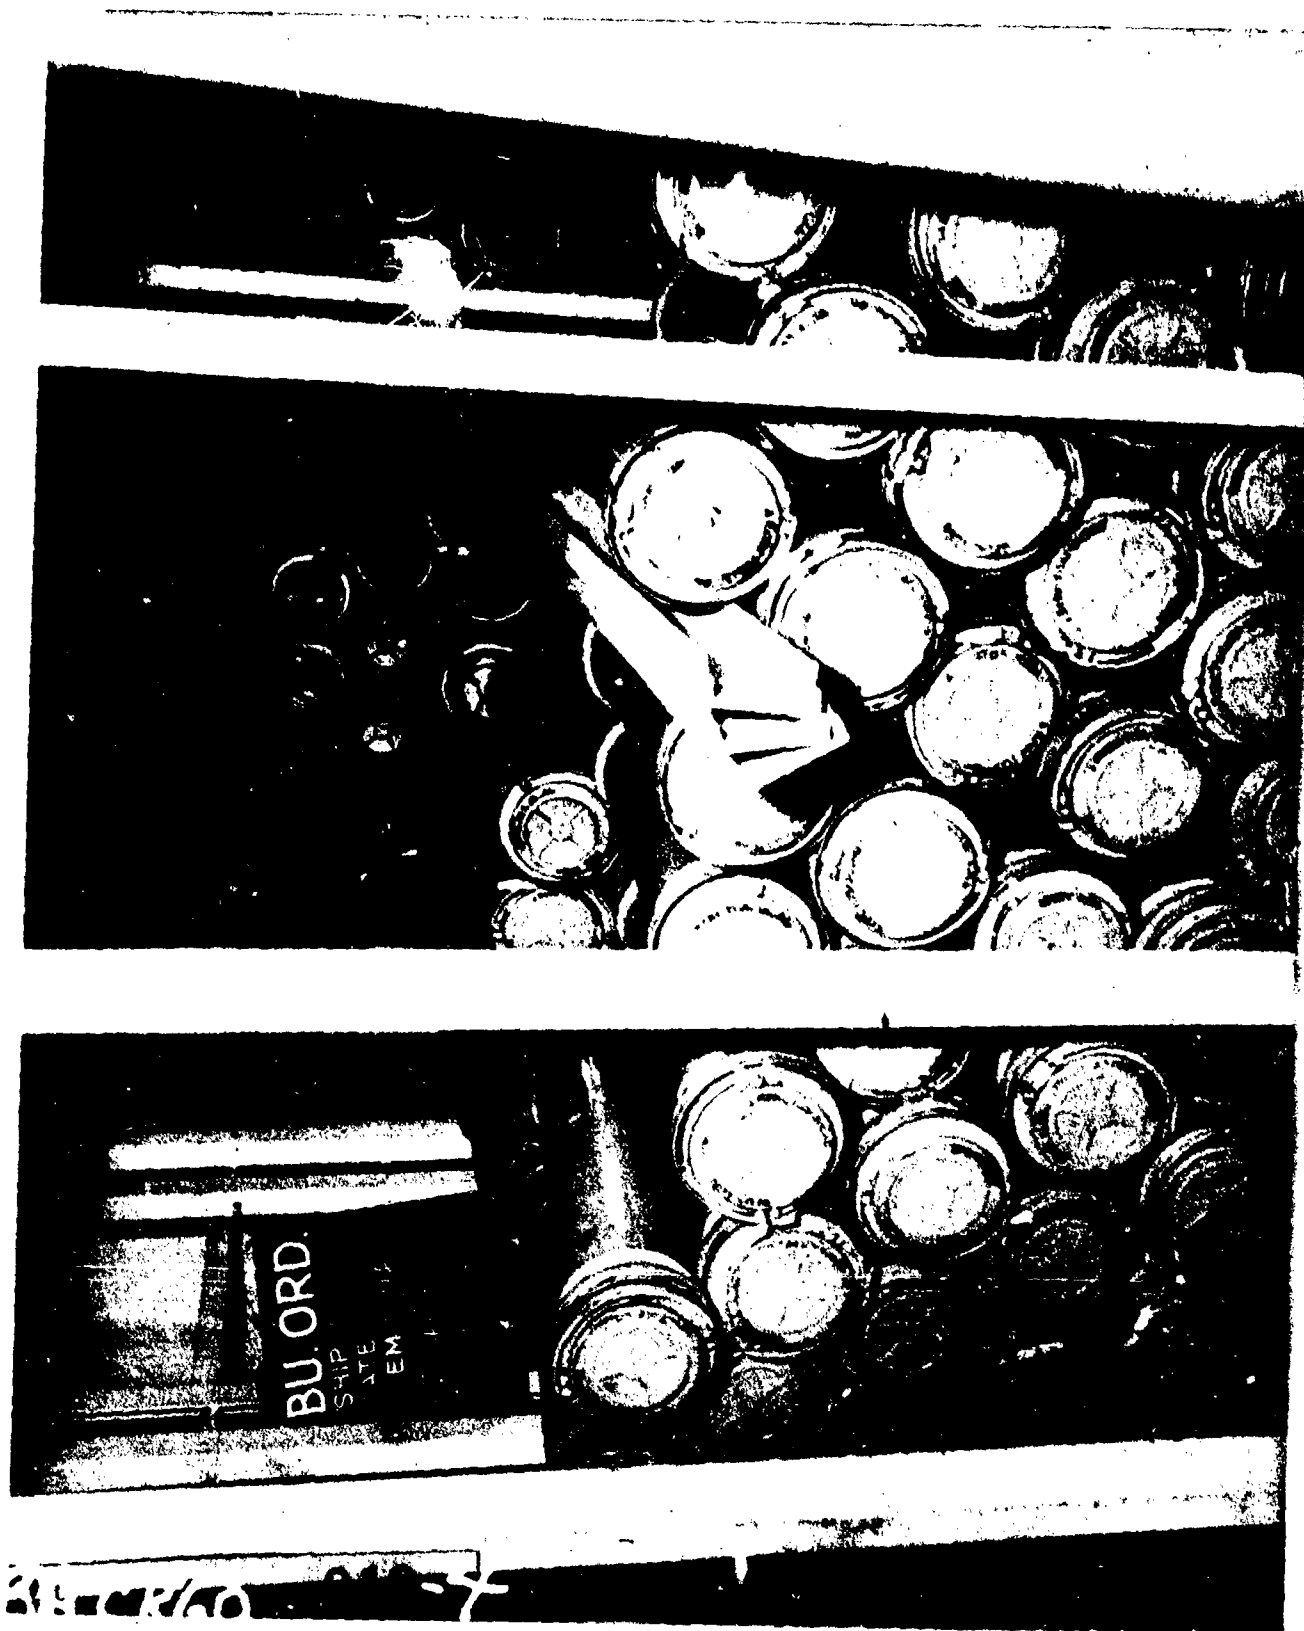
U.S.S. FALLON (APA-81) - Before Able  
Shows the 5"/38 Powder Storage in Magazine, C-306-M,  
prior to Test "A".  
Photo. No. BA-CR-60-218-4.

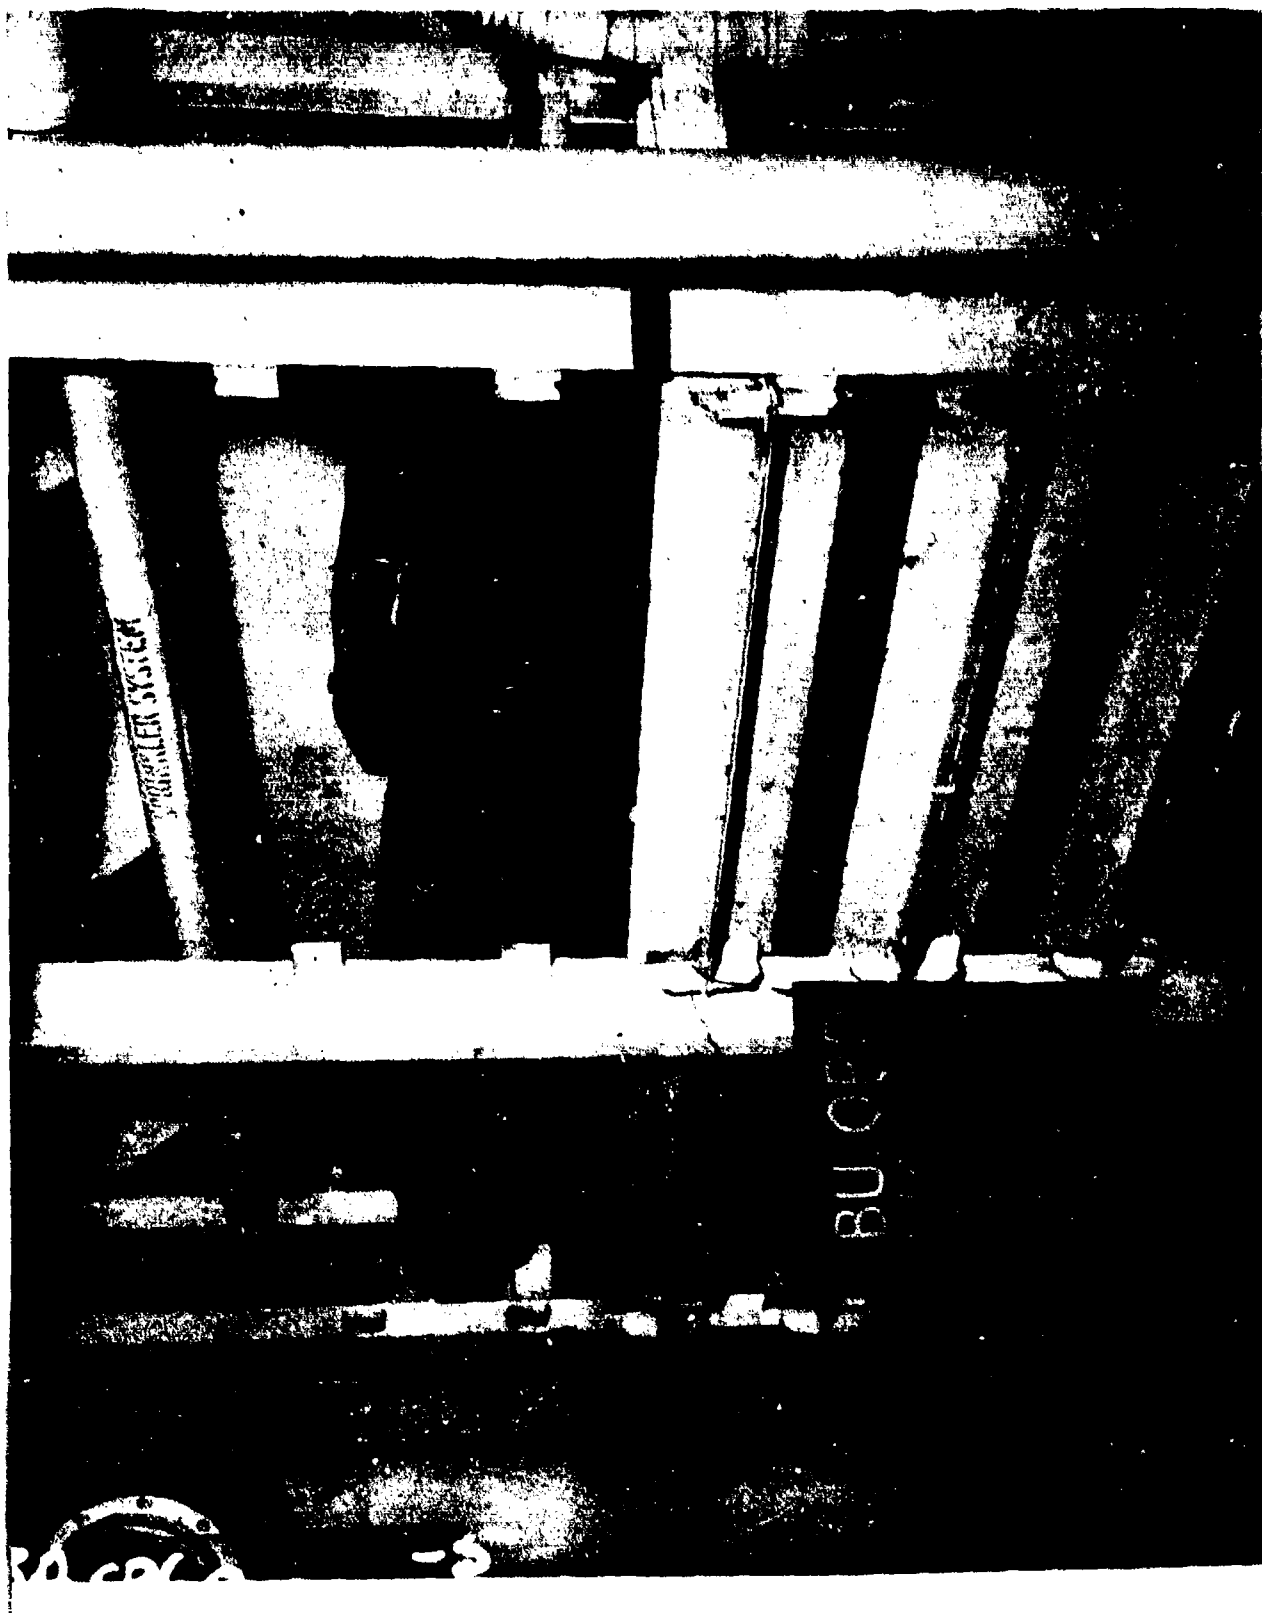
U.S.S. FALLON (APA-81) - Before Able  
Shows the 5"/38 Projectile Stowage in Magazine,  
C-305-M, prior to Test "A". All ammunition is  
Service Ammunition.  
Photo. No. BA-CR-60-918-5.

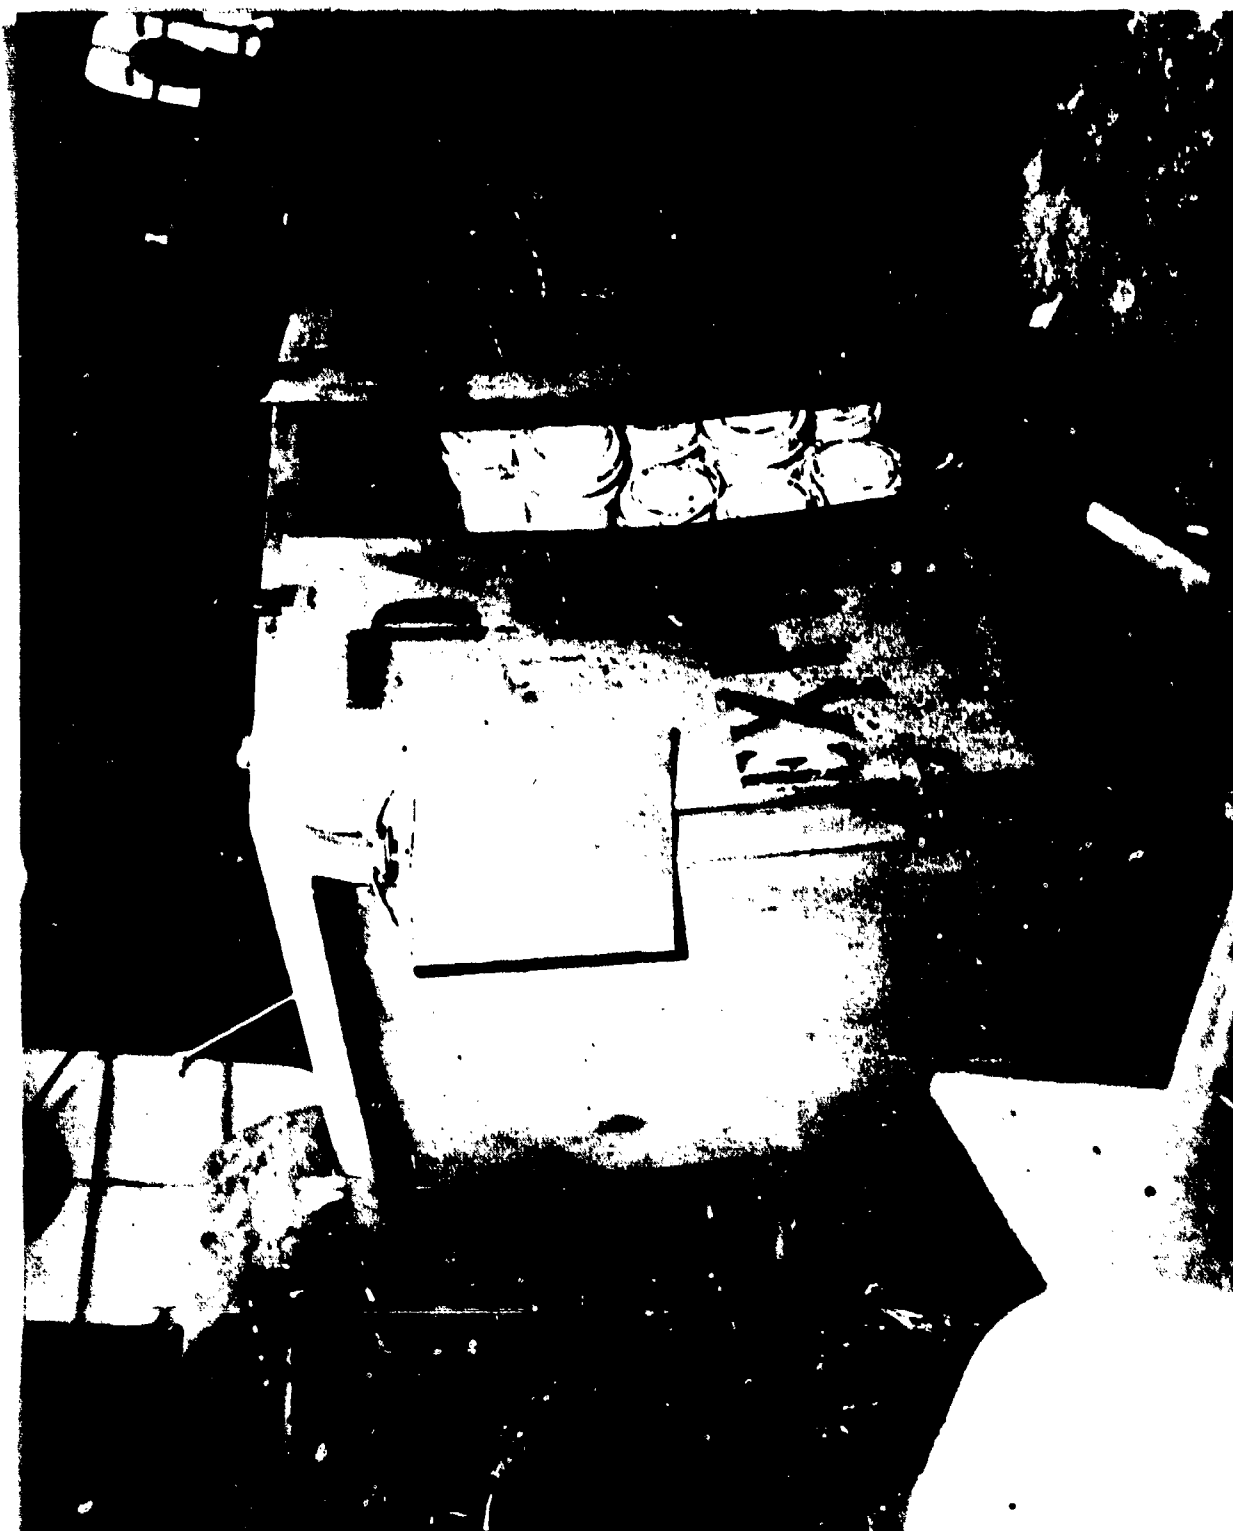
U.S.S. FALLON (APA-81) - After Able  
Shows the blast damage incurred to the 5"/38 Ready Service Locker and 5"/38 Powder  
Tanks. The Powder Tanks in position parallel to the edge of the doors were indented,  
however, withdrawal of the Cartridged Cases revealed no damage. Surveillance test  
of the smokeless powder exhibited no signs of damage or deterioration.  
Photo. No. AA-CR-87-2540-1.
